COURTLAND TOWNSHIP, MI

WASTEWATER SYSTEM

ASSET MANAGEMENT PLAN

October 5, 2018

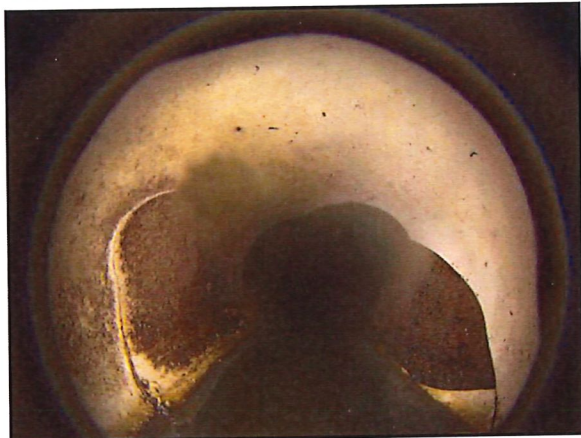
Figure 1: PS5_P077A; Condition: 5; Hole: Spot Repair

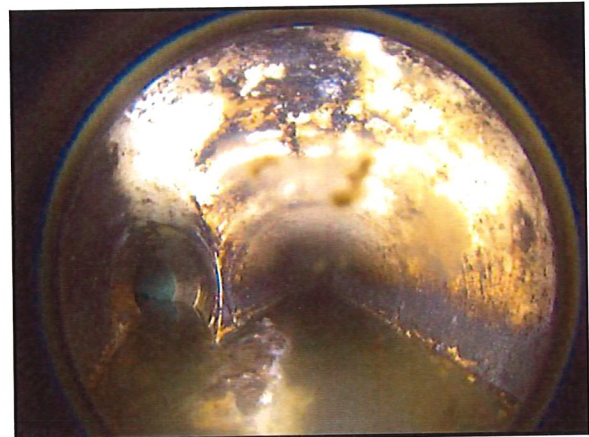
Figure 3: PS7_P044; Condition: 4; Deposits: Water Jet

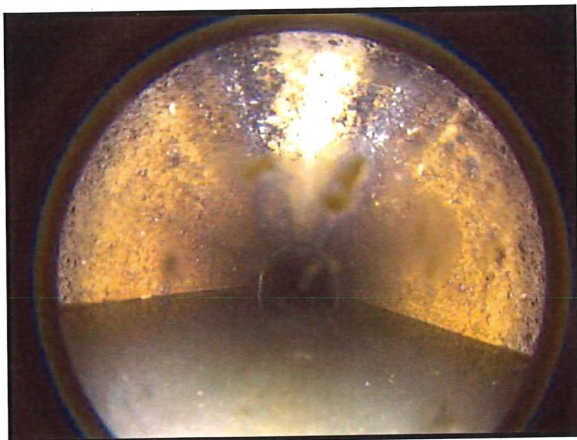
Figure 2: PS7_P044; Condition: 4; Water Level: Water Jet

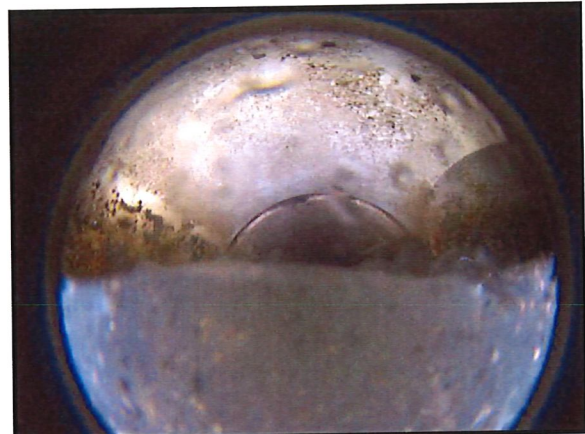
Figure 4: PS8_P048; Condition: 4; Water Level

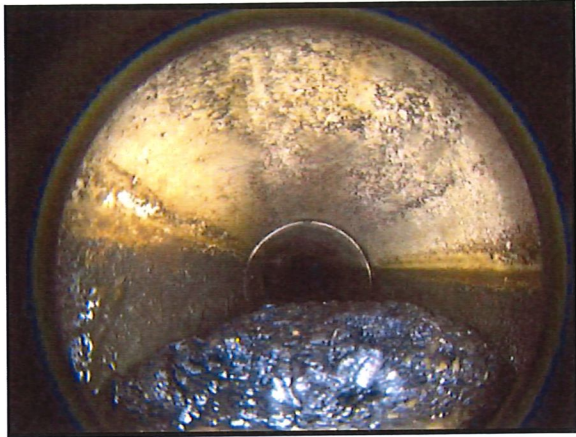
Figure 5: PS2_P099; Condition: 4; Obstacle: Water Jet

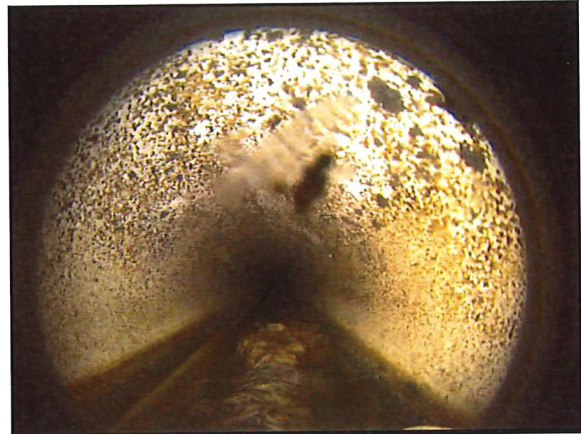
Figure 8: GP4_P084; Condition: 4; Deposits: Water Jet

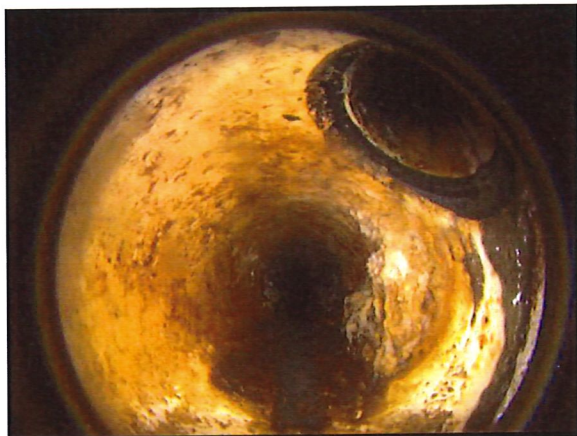
Figure 6: PS4_P121; Condition: 4; Deposits: Water Jet

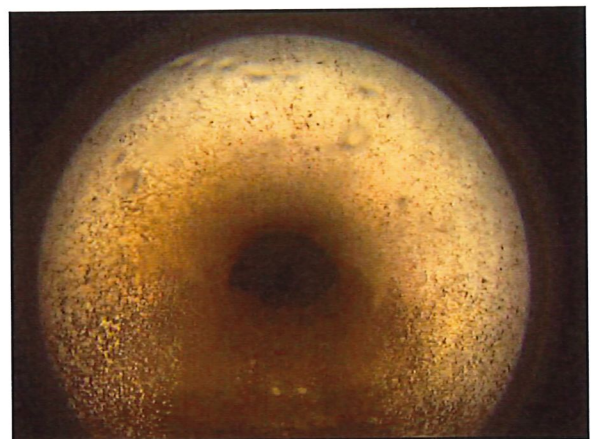
Figure 9: PS2_P098; Condition: 4; Deposits: Water Jet

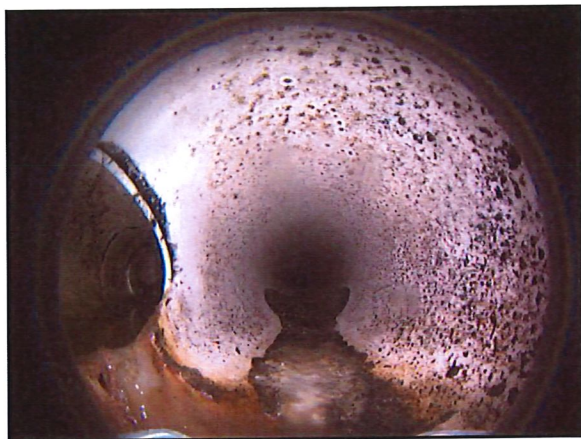
Figure 7: GP2_P019; Condition: 4; Deposits: Water Jet

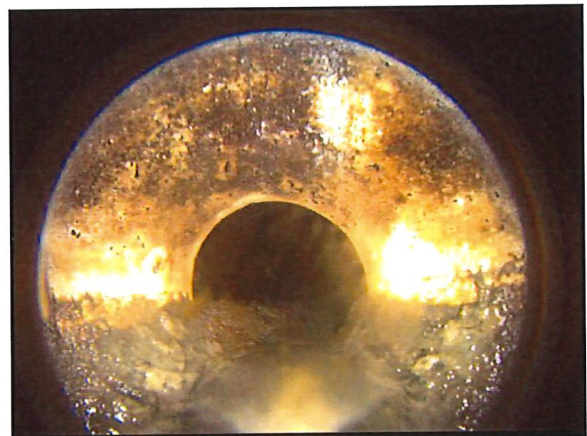
Figure 10: PS6_P023; Condition: 3; Deposits: Water Jet

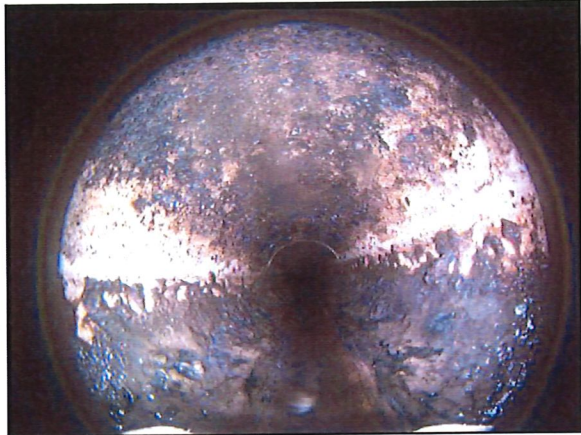
Figure 11: PS7_P036B; Condition: 3; Deposits: Water Jet

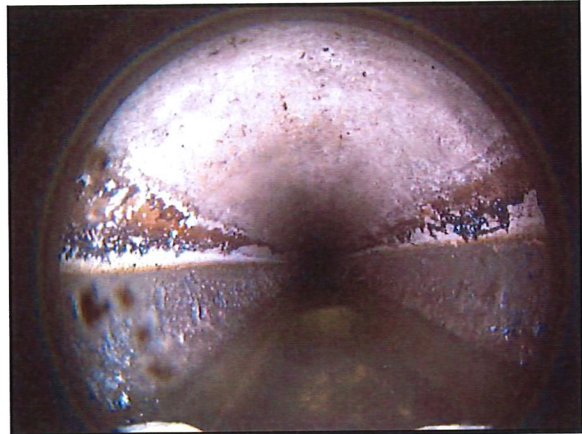
Figure 14: PS2_P100; Condition: 3; Deposits: Water Jet

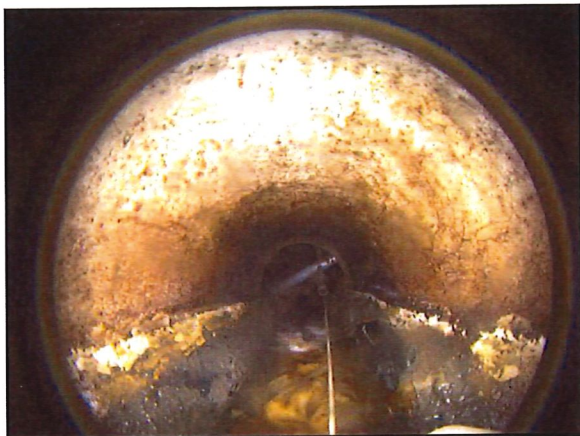
Figure 12: PS9_P055; Condition: 3; Deposits: Water Jet

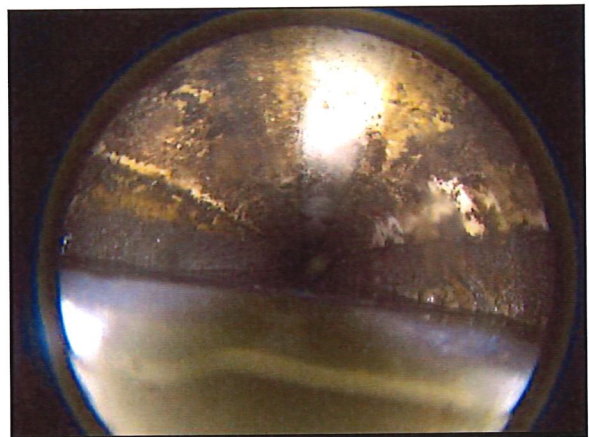
Figure 15: PS7_P043; Condition: 3; Deposits: Water Jet

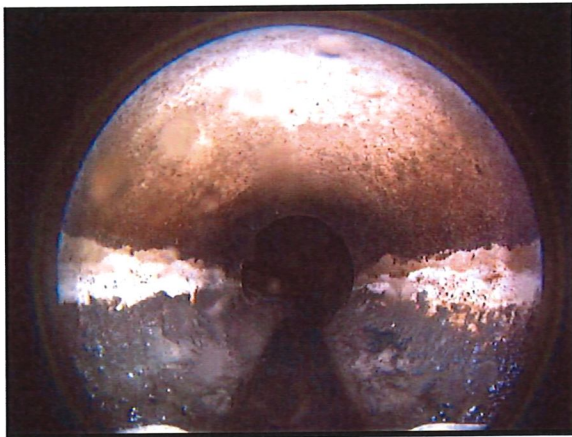
Figure 13: PS8_P050; Condition: 3; Deposits: Water Jet

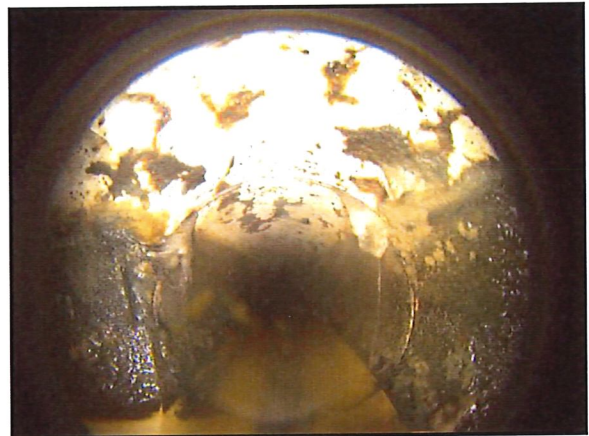
Figure 16: PS6_P024; Condition: 3; Deposits: Water Jet

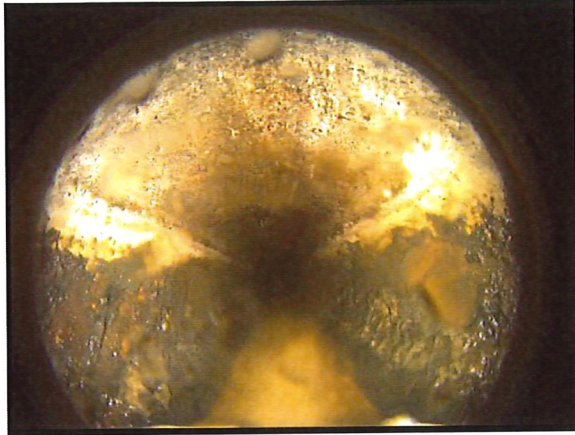
Figure 17: PS1_P002; Condition: 3; Deposits: Water Jet

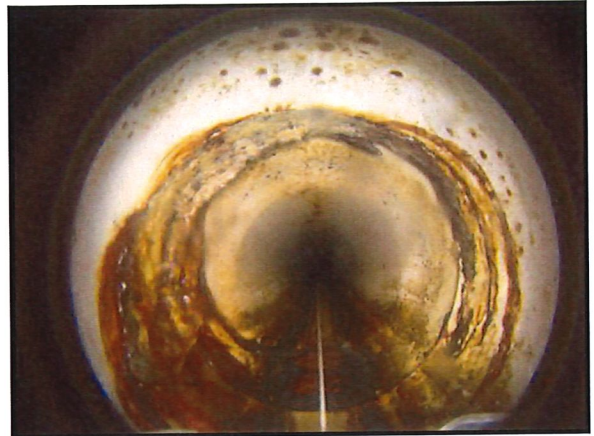
Figure 20: PS10_082A; Condition: 3; Encrustation

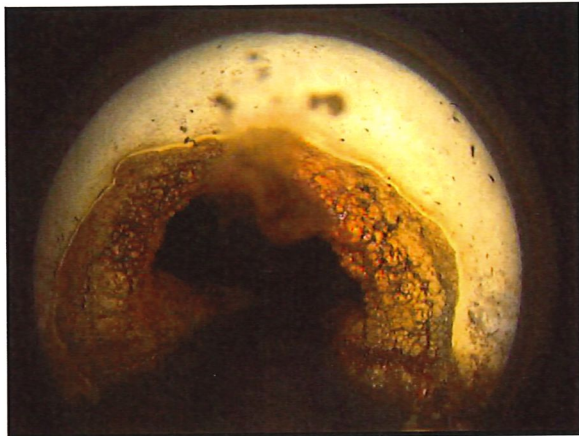
Figure 18: PS5_P031; Condition: 3; Encrustation

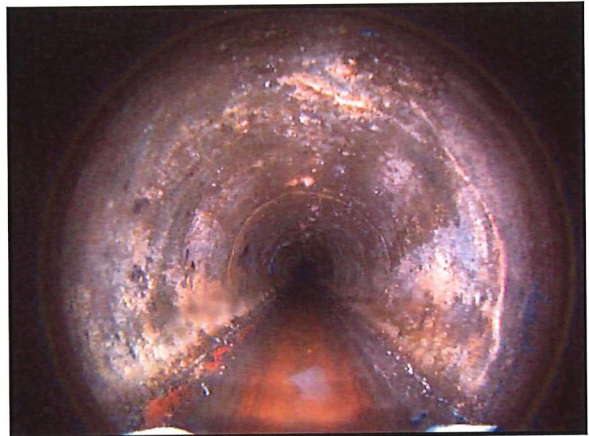
Figure 21: PS4_P114; Condition: 3; Crack Multiple: CIPP

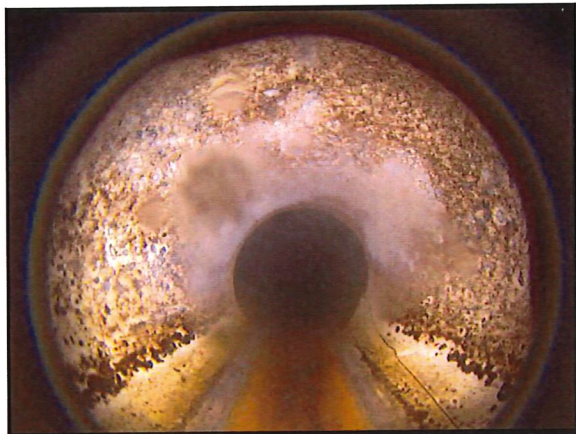
Figure 19: PS10_P065; Condition: 3; Spiral Crack

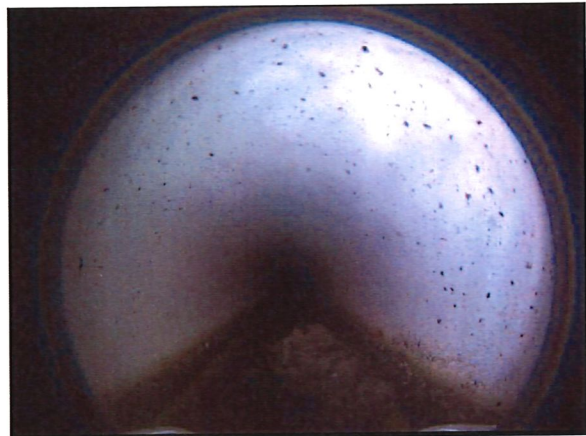
Figure 22: PS5_P033A; Condition: 3; Obstacle: Water Jet

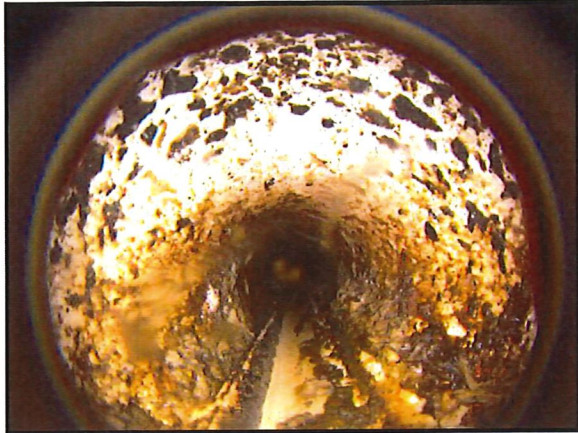
Figure 23: PS6_P021; Condition: 3, Deposits: Water Jet

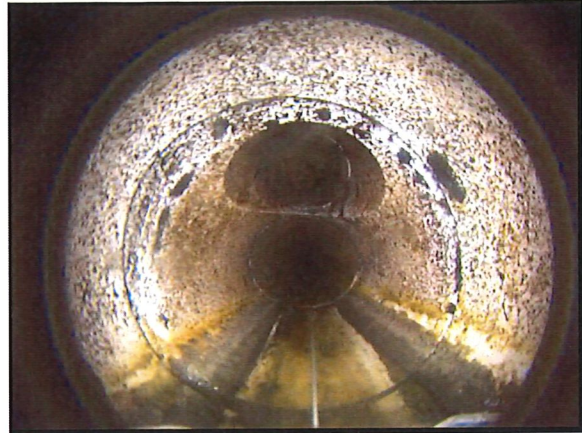
Figure 25: GP2_P016; Condition: 0; Tap Factory

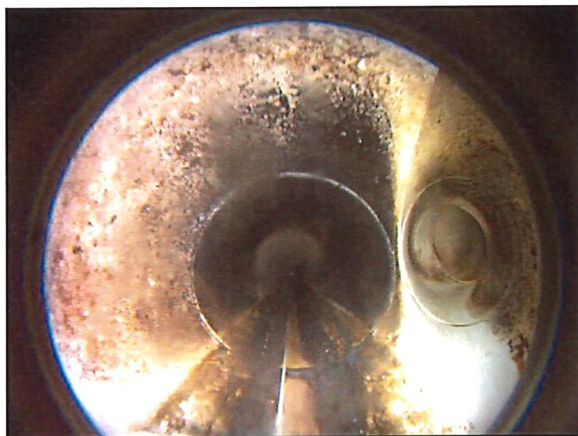
Figure 24: PS4_P120; Condition: 2; Deposits Fine: Water Jet

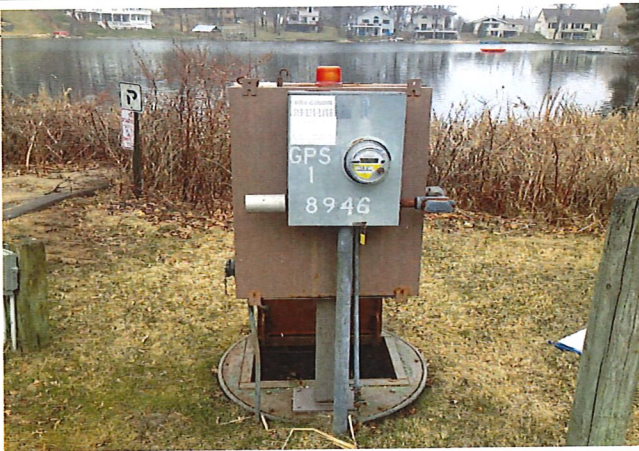
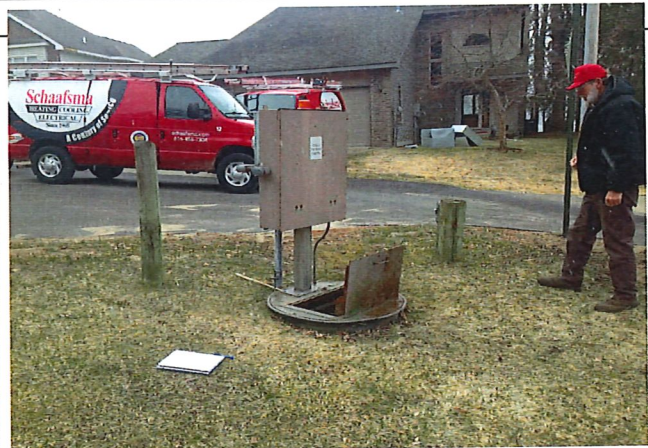
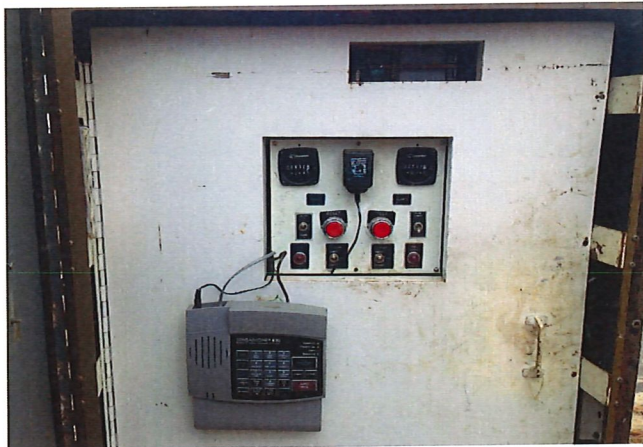
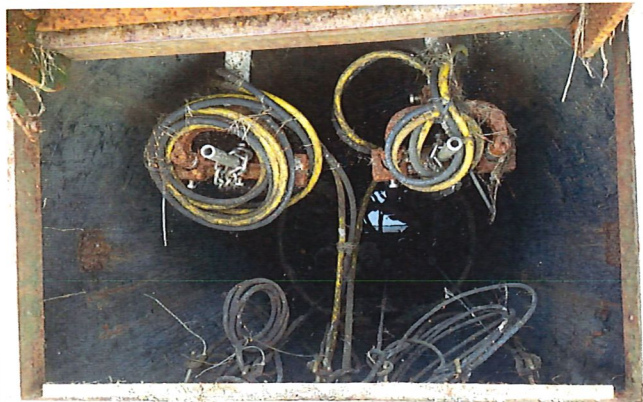
Corrosion on lid

Wet Well Steel Replacement

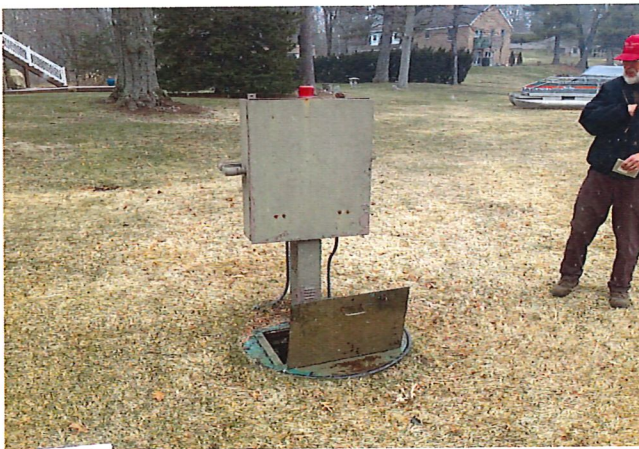
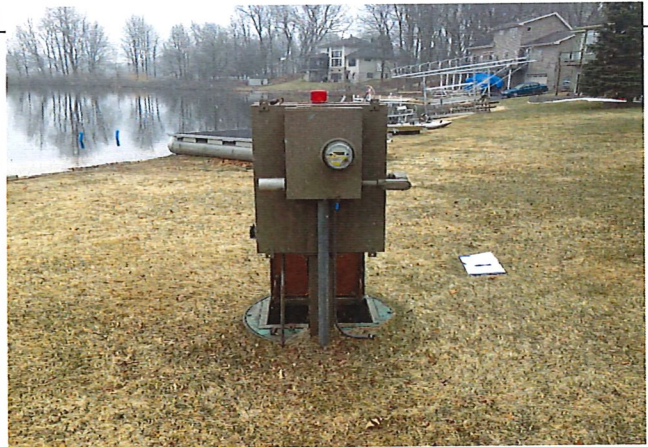
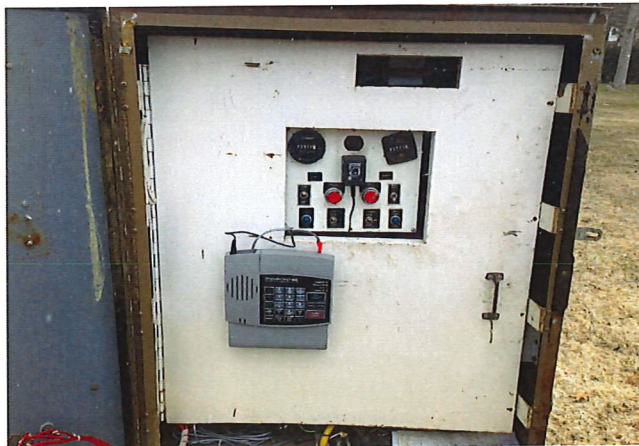
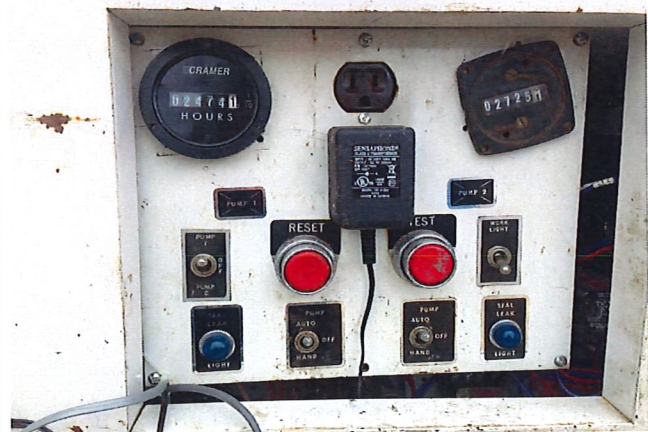
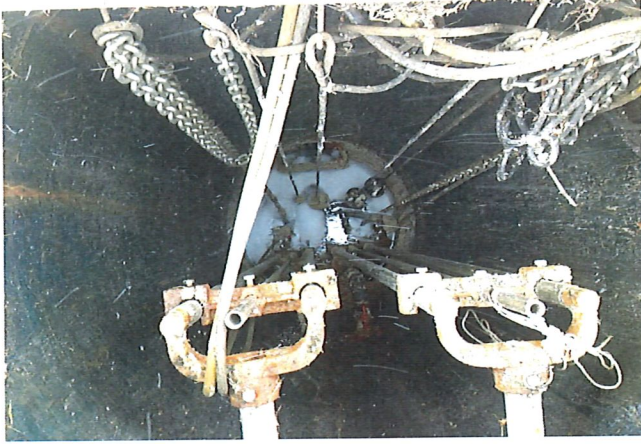
Corrosion on lid

Rusted Steel Baffle Plate
