COURTLAND TOWNSHIP, MI

WASTEWATER SYSTEM

ASSET MANAGEMENT PLAN

October 5, 2018

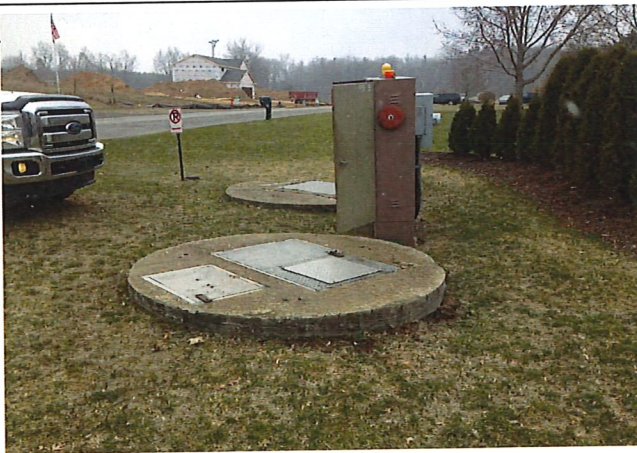
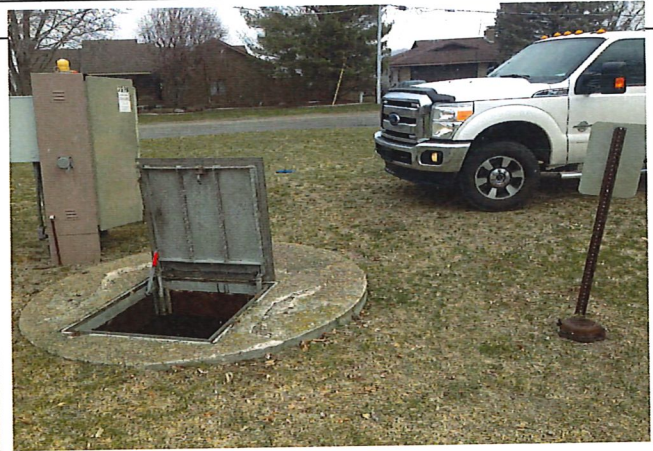
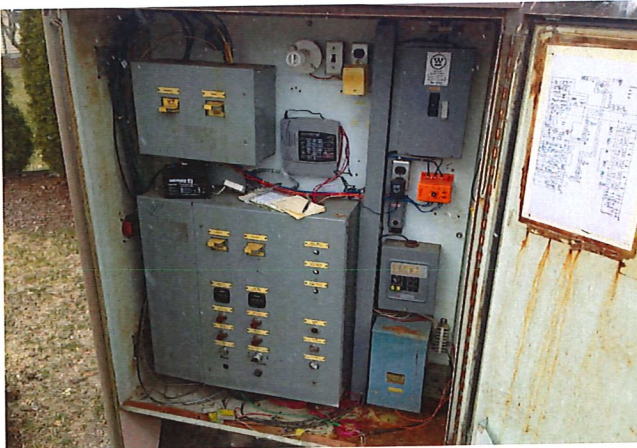
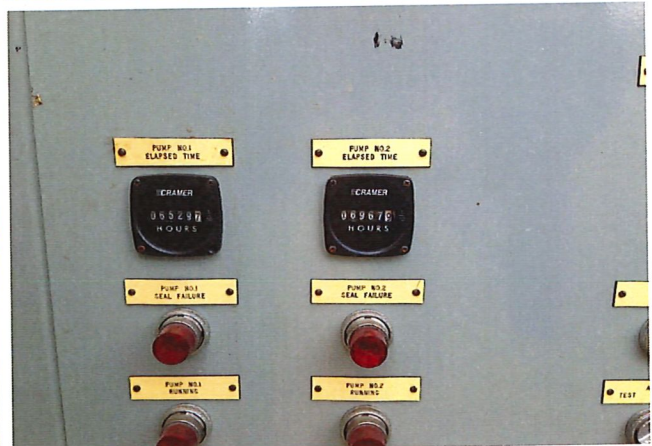
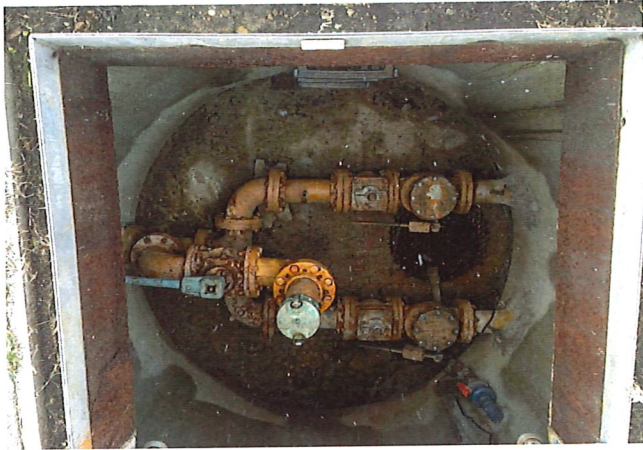
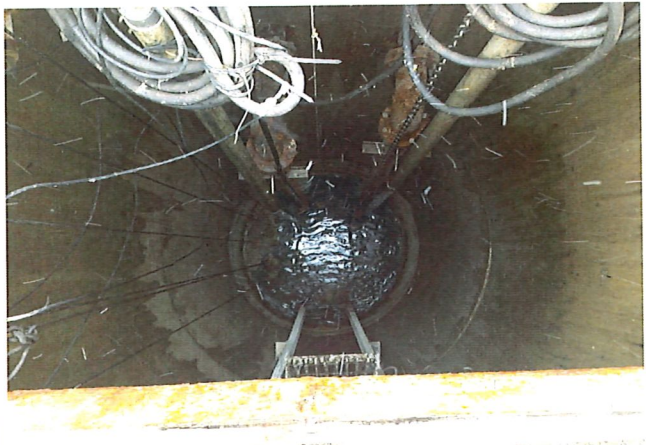
Incoming Power: 480V, 3 Ph
 Backup Power: MTS and Generator Connection
 Over/Underground: Underground
 Phase Converter: None
 Pump Controller: Warrick Controls ISR
 Level Control: Floats
 Backup Level Control: Floats
 Pump Alternator: Manual
 Flow Meter: None
 Panel Condition: Poor (Sinking)

Only 2' of operating range

Extra alarm light and loud bell for extra protection

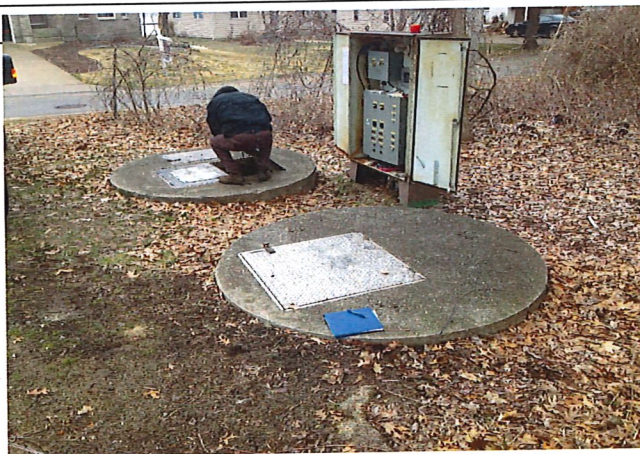
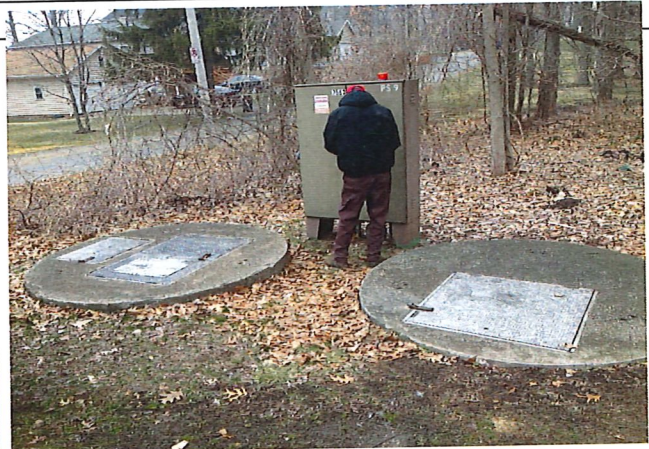
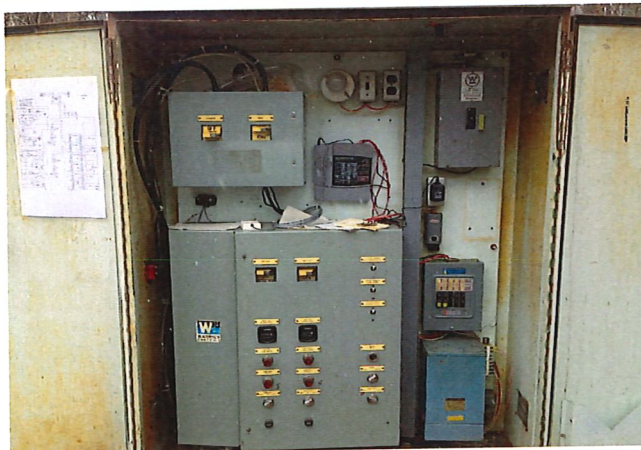
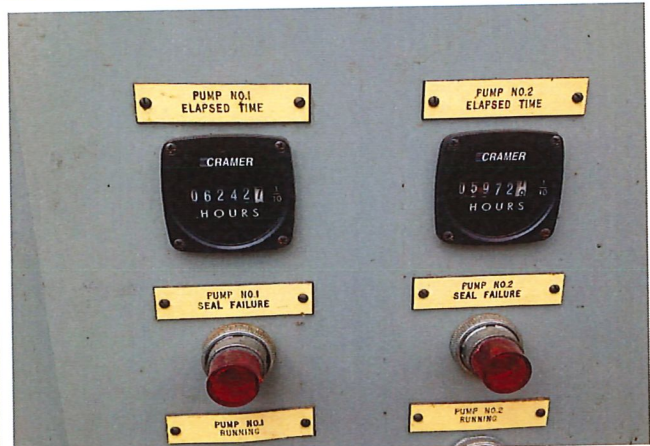
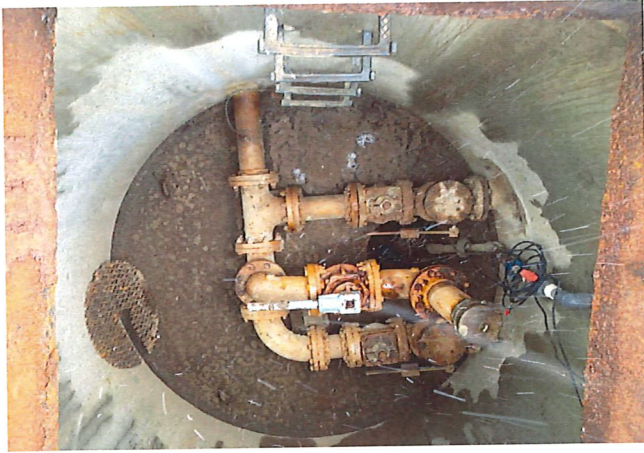
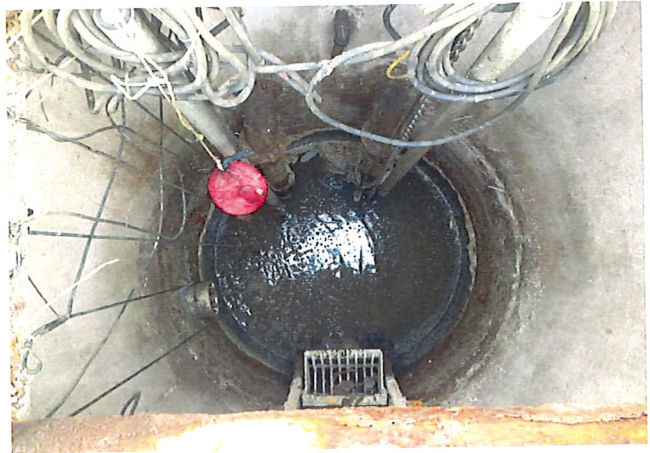
Courtland Township
Sanitary Lift Station Review Sheet

Age/Corrosion

All downstream pump stations have been coated

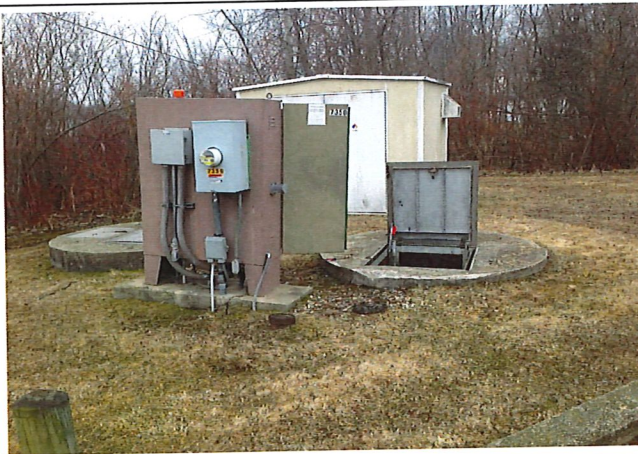
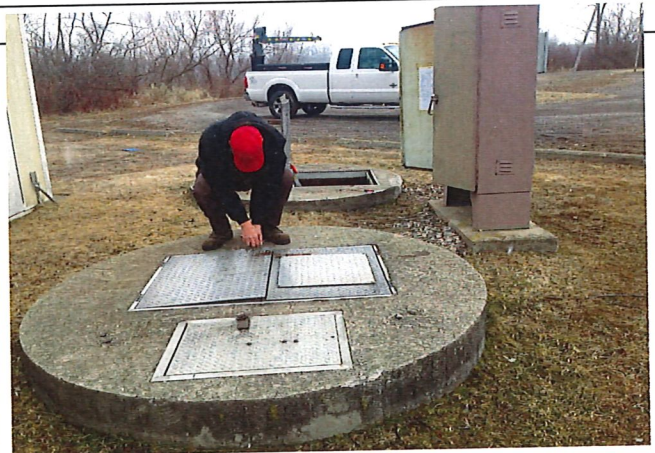
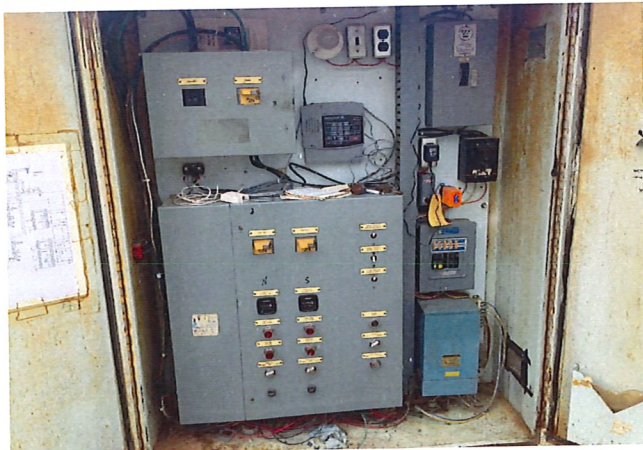
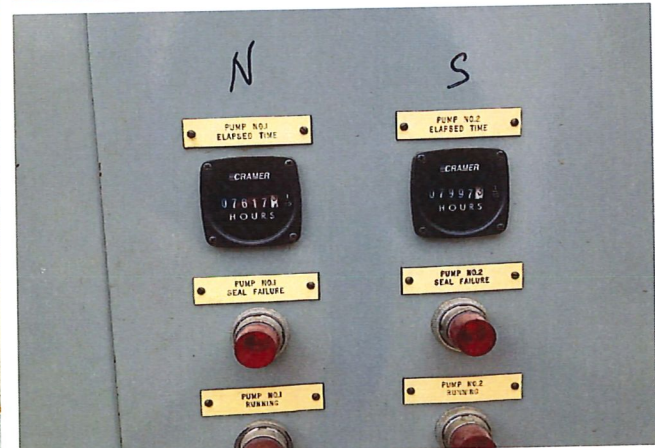
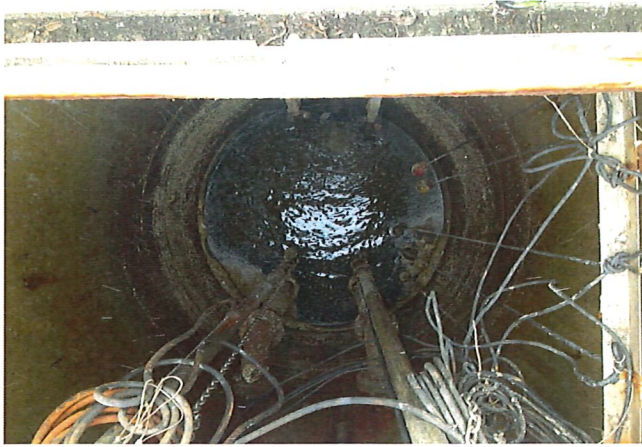
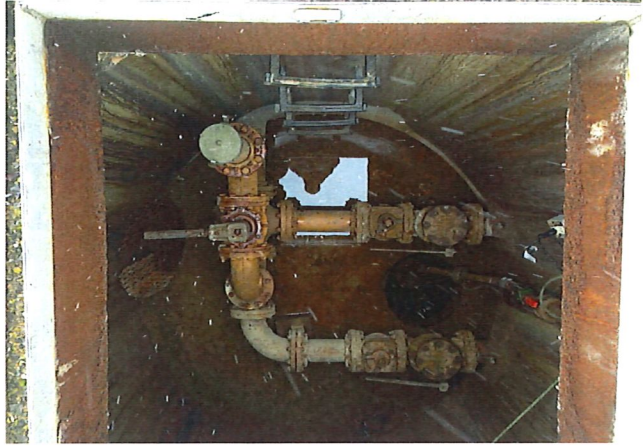
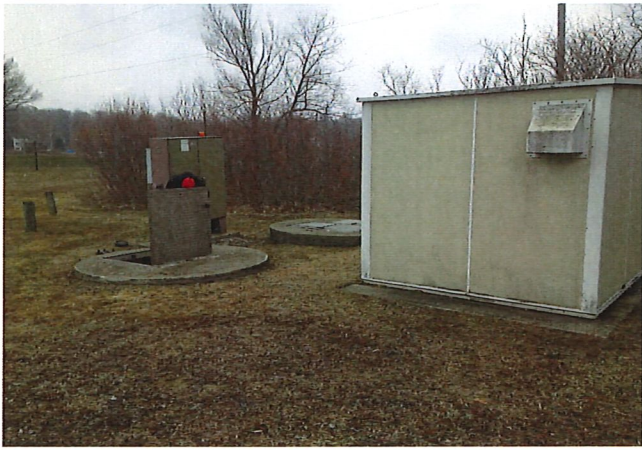
**Courtland Township
Sanitary Lift Station Review Sheet**

Incoming Power: 480V, 3 Ph
 Backup Power: MTS and Generator Connection
 Over/Underground: Underground
 Phase Converter: None
 Pump Controller: Warrick Controls ISR
 Level Control: Floats
 Backup Level Control: Floats
 Pump Alternator: Manual
 Flow Meter: None
 Panel Condition: Fair (Settling)

Age/Corrosion

Must clean out every 3 months because of wipes, grease, scum

Same impeller as PS1 but clogs a lot more
